PWD & EPI VCAP SITE

RESULTS & RECOMMENDATIONS FROM VULNERABILITY ASSESSMENTS & COMMUNITY ENGAGEMENT

Recommendations for PWD: Epi VCAP Site

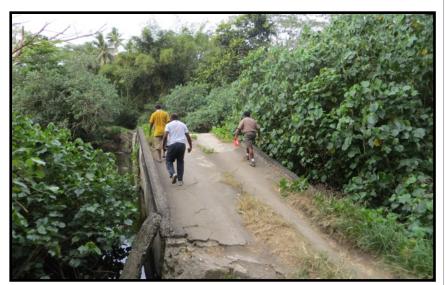
(Collapsed bridge near Yervali School is no longer accessible to vehicles)

There is a **large collapsed bridge** adjacent to **Yervali School near Ruwo** that can no longer be accessed by vehicles. This collapsed bridge is producing significant erosion problems. A temporary route leading to an alternate crossing location (without any bridge) has been created approximately 100 meters further inland. This newly improvised crossing requires that locals must regularly clear out large stones and logs blocking vehicle access. **Building a bridge at this location further inland**, that will allow for safe passage regardless of the weather, was reported as a priority by communities here.

- New bridge constructed near Yervali School; and partial demolition of collapsed bridge to allow for natural drainage of river and coastal storm surge

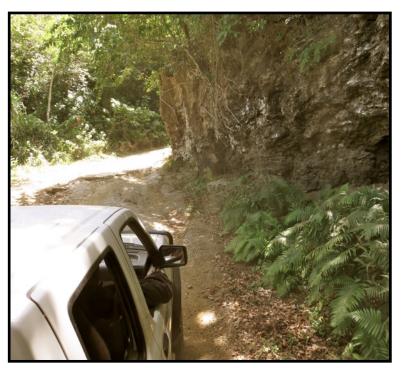
(Many slopes located along roadside are adjacent to vertical stone cliffs)

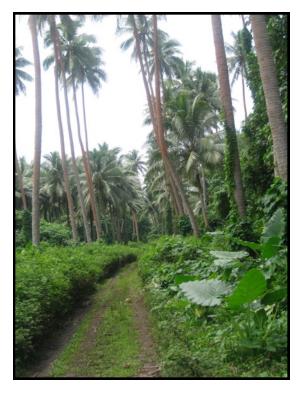
(Road near Mabfilau passing through coconut plantation)

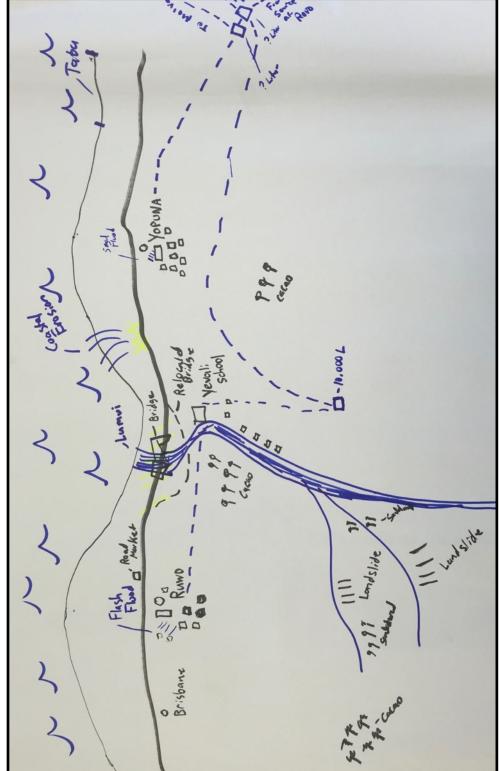
<u>Community Mapping - Ruwo / Yopuna VDC</u>

Community mapping exercise showing climate related vulnerabilities as indicated by community along the primary road passing through Ruwo and Rovoliu. The dark black line denotes the location of primary road, solid blue lines denote river and creeks, dotted blue lines indicates the location of gravity feed water supply system and yellow marker shows the location of climate vulnerabilities indicated by community members.

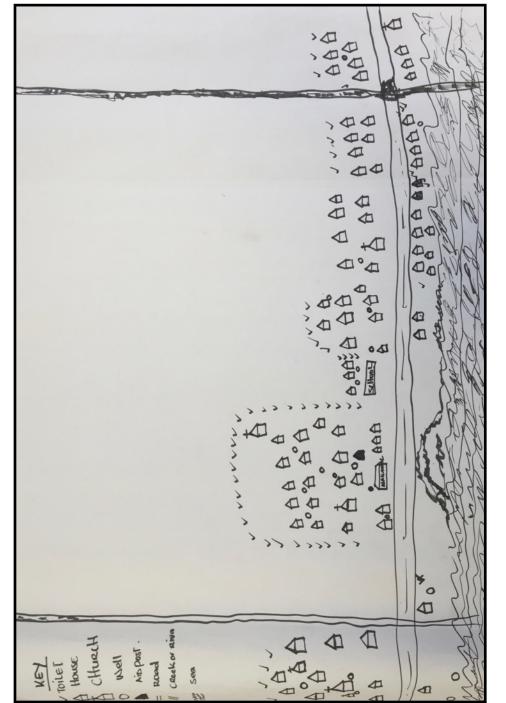
Community Mapping - Ponkovio VDC

Community mapping exercise showing climate related vulnerabilities, in particular the river and creek crossings, as indicated by community along the primary road passing through and near Ponkovio.

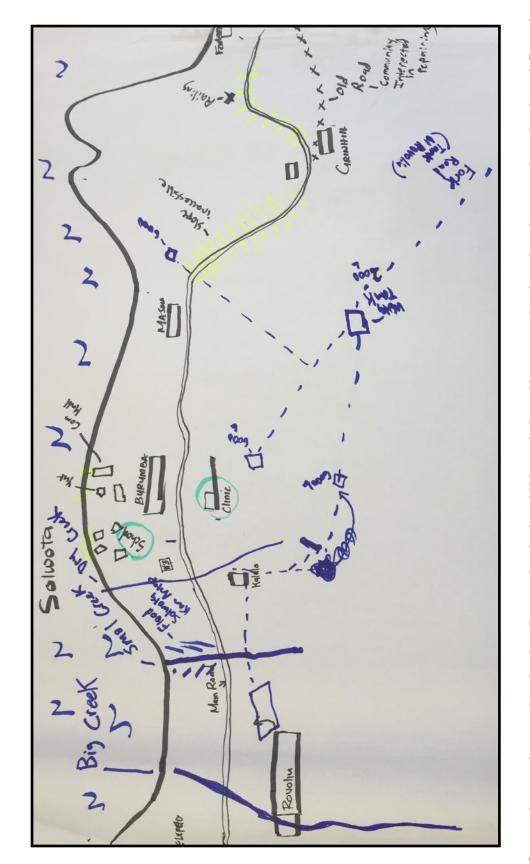
Community Mapping -Burumba VDC

Community mapping exercise showing climate related vulnerabilities as indicated by community along the primary road passing through Burumba and Rovoliu. Twin black lines denote the location of primary road, solid blue lines denote river and creeks, dotted blue lines indicates the location of gravity feed water supply system and yellow marker shows the location of climate vulnerabilities indicated by community members.
