PWD & EPI VCAP SITE

RESULTS & RECOMMENDATIONS FROM VULNERABILITY ASSESSMENTS & COMMUNITY ENGAGEMENT

Recommendations for PWD: Epi VCAP Site

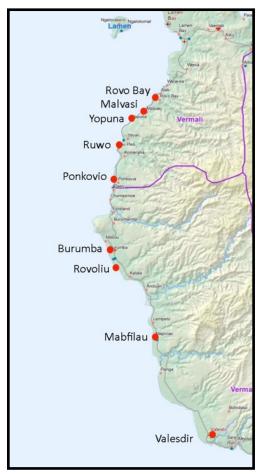
There is one slope in this area as well that could benefit from improved materials such as cement to improve accessibility in wet conditions, along with the installation of drainage to prevent

erosion.
